Xbox 360 E Button Board Replacement

Replace the button board on the Xbox 360 E.

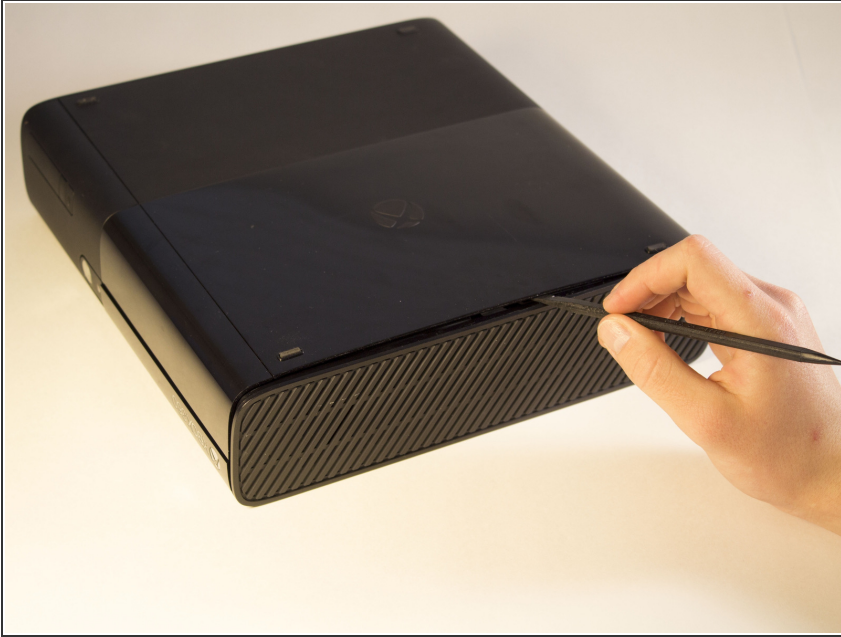
Step 1 — Top Panel

- Push the [Spudger](#) into the crevice between the grated top panel of the Xbox and the bottom body with the rubber feet.
- Pull back on the spudger like a lever, keeping it pressed firmly into the crevice.

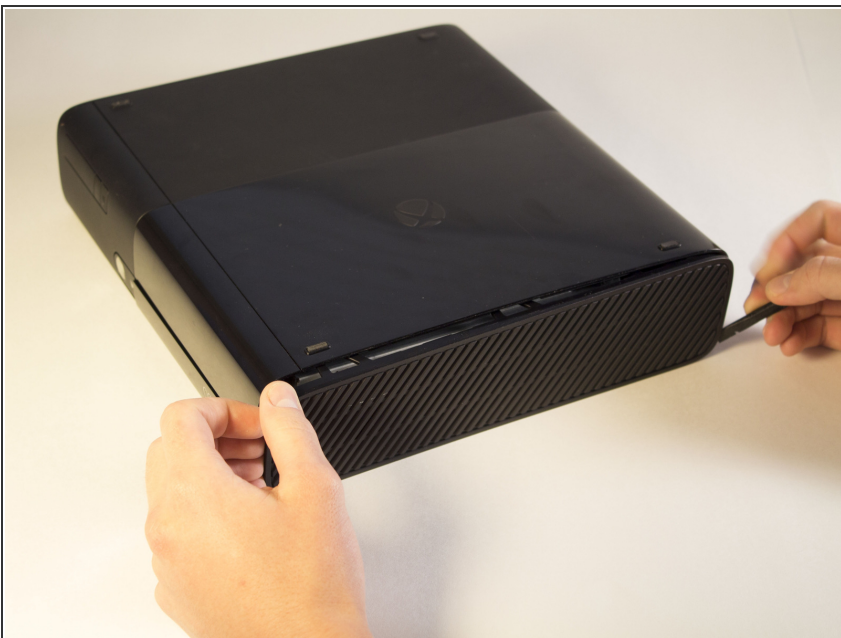
Step 2

- Slide the spudger along the separation you have created between the grated panel and the bottom body of the Xbox.
- Periodically pull back on the spudger like a lever, keeping it pressed firmly into the crevice.

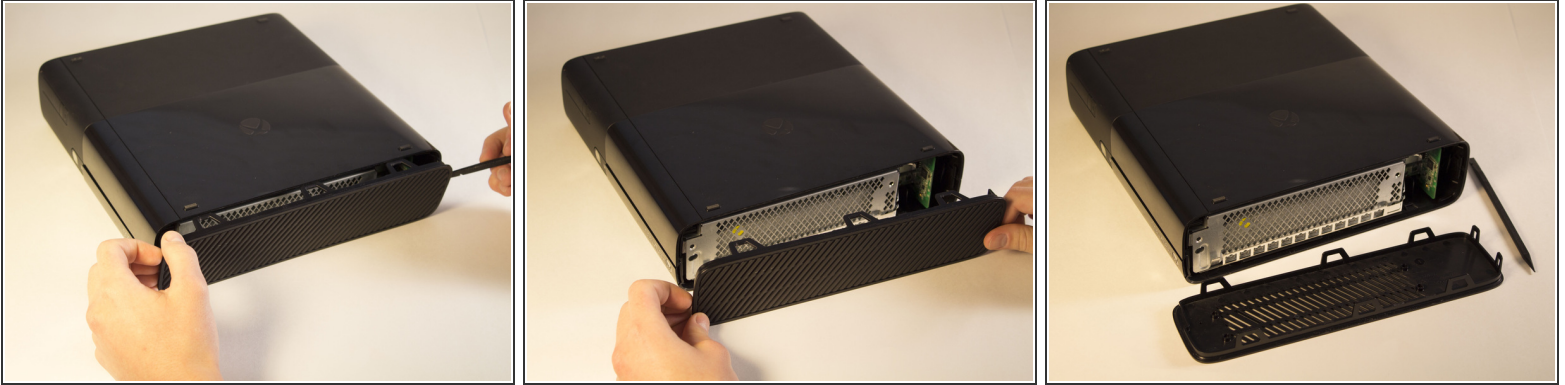
Step 3

- Continue sliding the spudger along the perimeter of the left grated face of the Xbox.
- Pull the top panel off.

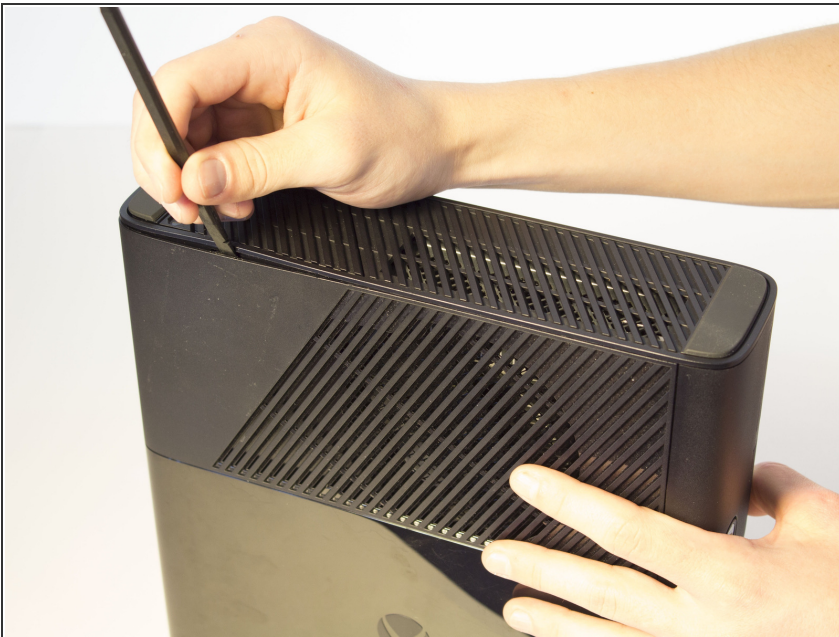
Step 4 — Bottom Panel

- Push the spudger into the crevice between the right grated face and the top body of the Xbox. It's easier to begin away from the vent.
- Pull up on the spudger like a lever, keeping it pressed firmly into the crevice.

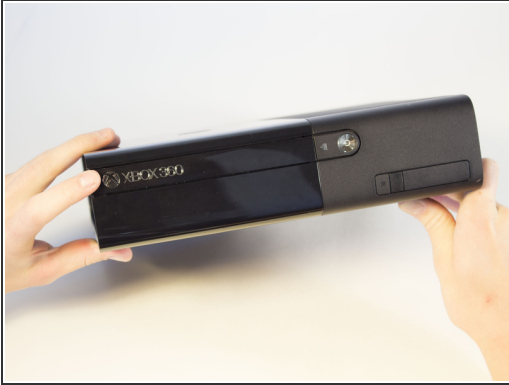
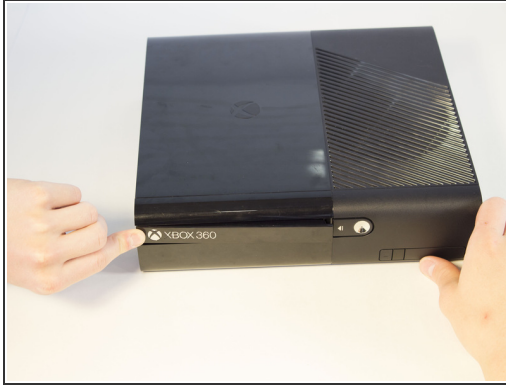
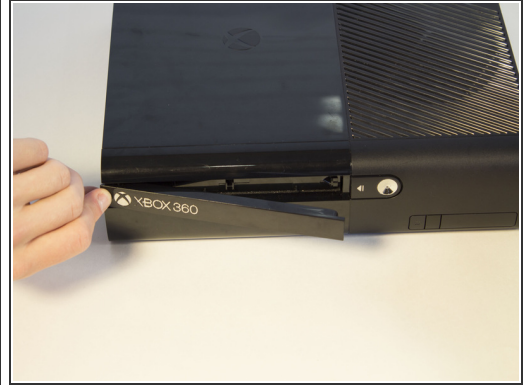
Step 7 — Front Panel

- In front of the CD drive you will find the Xbox logo. Press on the area left of the Xbox logo, and the disk tray panel will pop off.

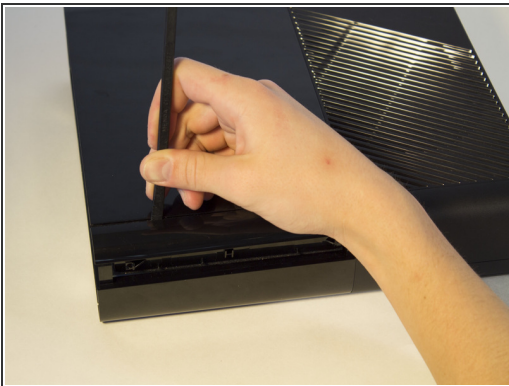
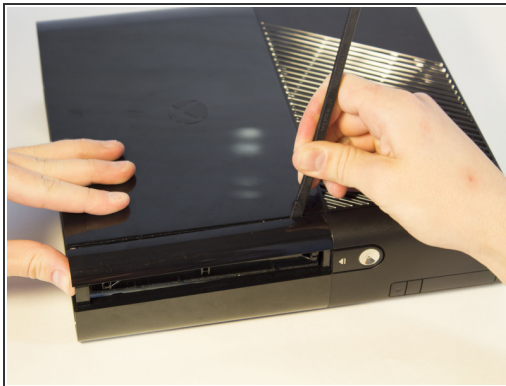
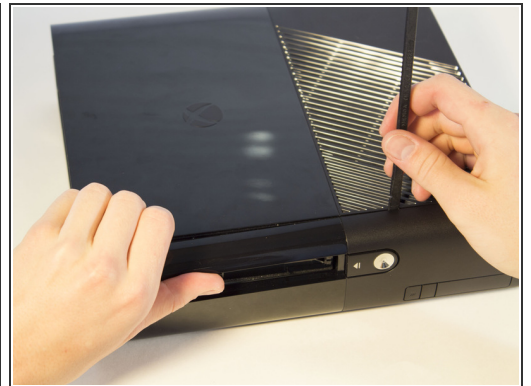
Step 8

- Beginning on the left side without the grate, run the spudger along the crevice until you've reached the grated part, while holding the part that's being separated as you go.

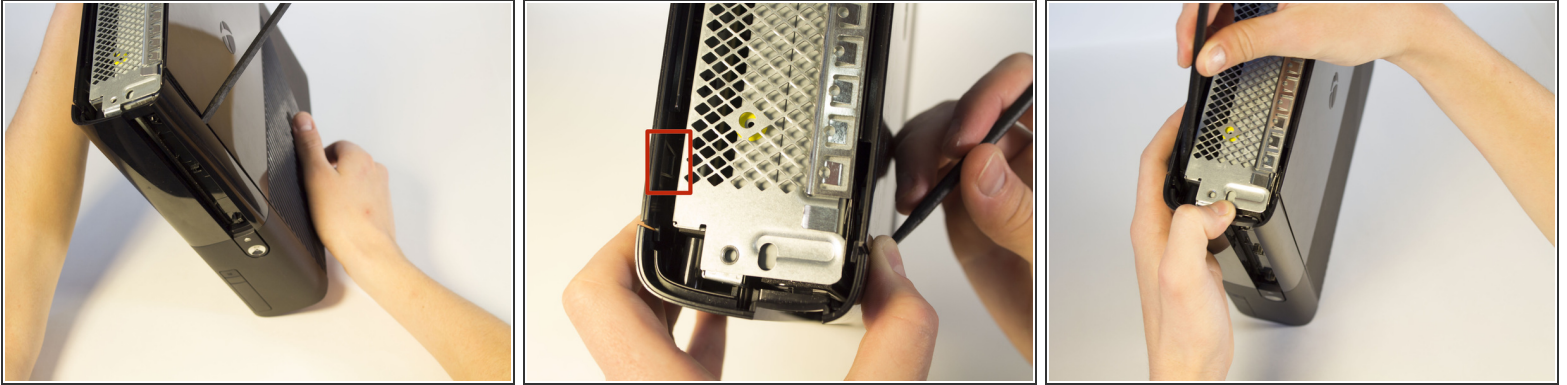
Step 9

- Keep holding the partially separated panel open. It's easiest to do this by wedging a spudger into the opening but can also be held open by your hands.
- Rotate the Xbox to the left to locate the clip connecting the front panel to the body. Insert the spudger inside the gap to release the clip. This may require wiggling the spudger. The clip will pop off, making the front panel looser.

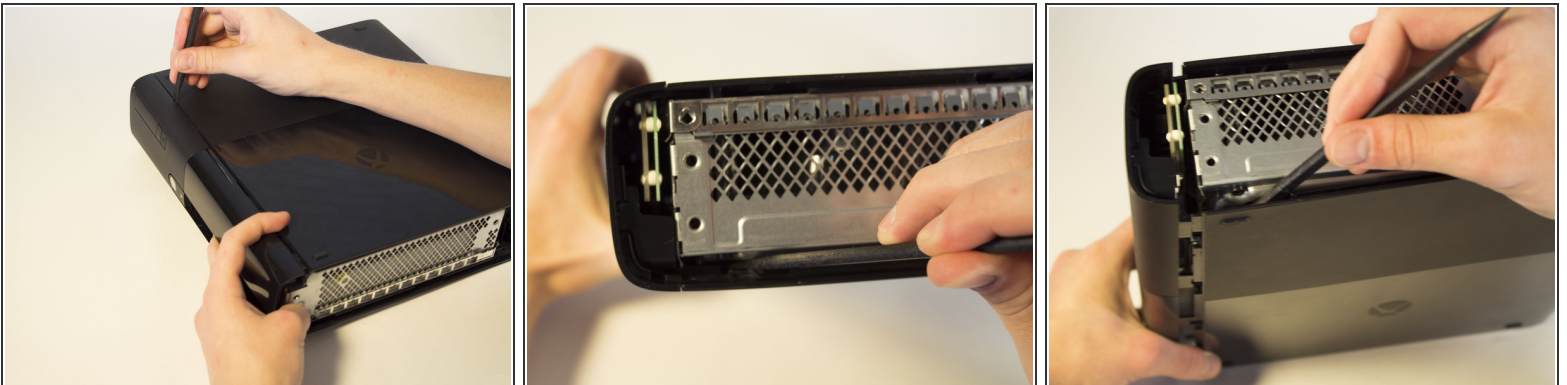
Step 10

- Flip the Xbox so the opposite side is towards you. Make sure to keep the separation open.
- Locate the other clip and insert the spudger to remove it.

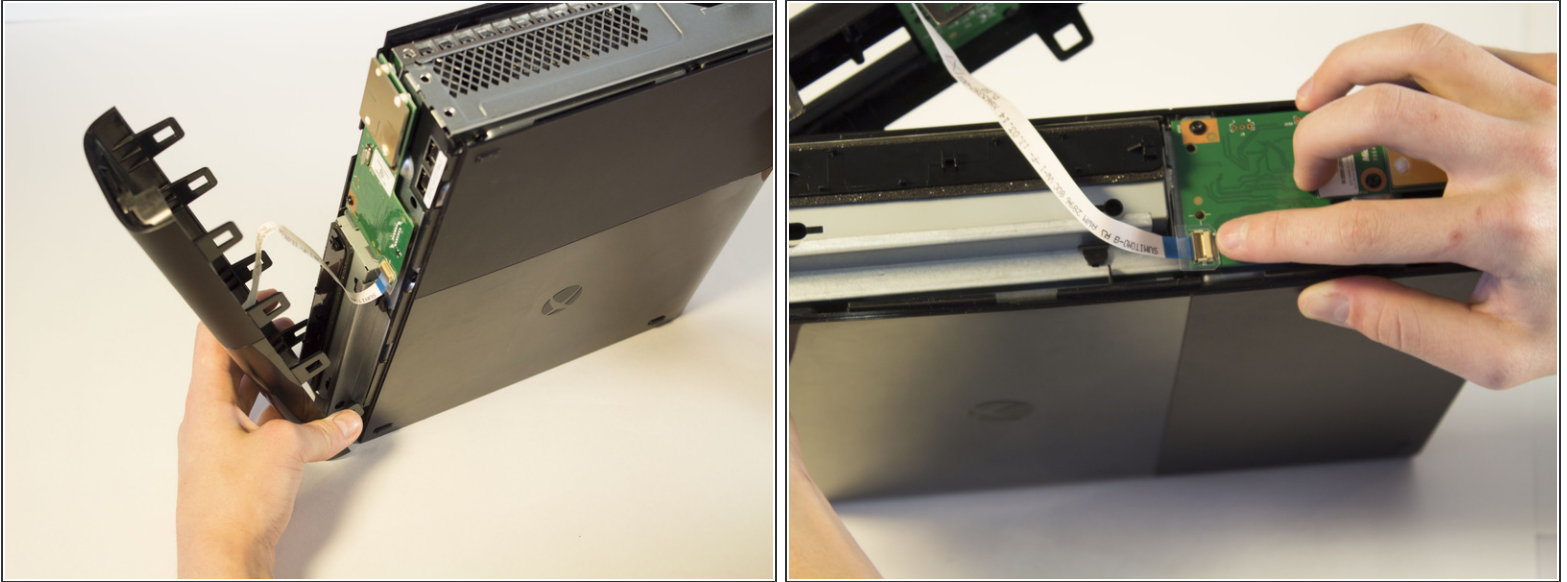
Step 11

- Continue to run the spudger along the crease to release any further clips that may still be attached.

Do not pull off the panel too fast because you don't want to damage the ribbon cable. Slowly pull away the panel.

- Now that the front panel has been released from its clips you can pull off the front panel.

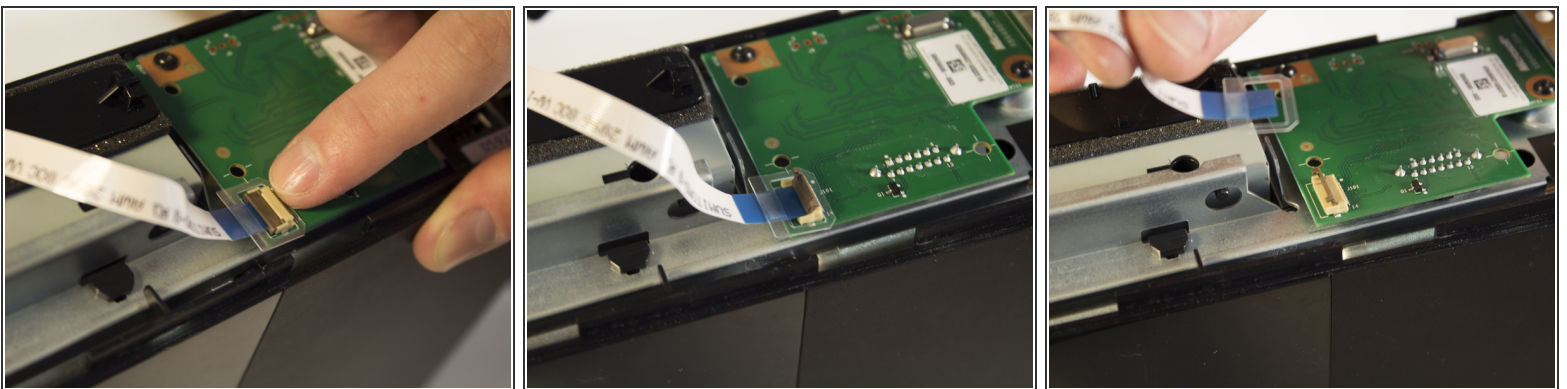
Step 12

- Find the brown section where the ribbon cable enters the green board. Flip the brown part up and pull out the plastic tab at the end of the ribbon.
